SPECIAL ISSUE

OCTOBER, 1969

NATURAL FEATURES CAUSED BY A CATASTROPHIC STORM IN NELSON AND AMHERST COUNTIES, VIRGINIA

The State Geologist received authorization from the Office of Civil Defense to inspect the flood-damaged area. The photographs appearing in this article were taken by staff members of the Virginia Division of Mineral Resources, Thomas M. Gathright and Donald W. Hutcheson, who accompanied Dr. James L. Calver on the inspection trip, August 28, 1969.

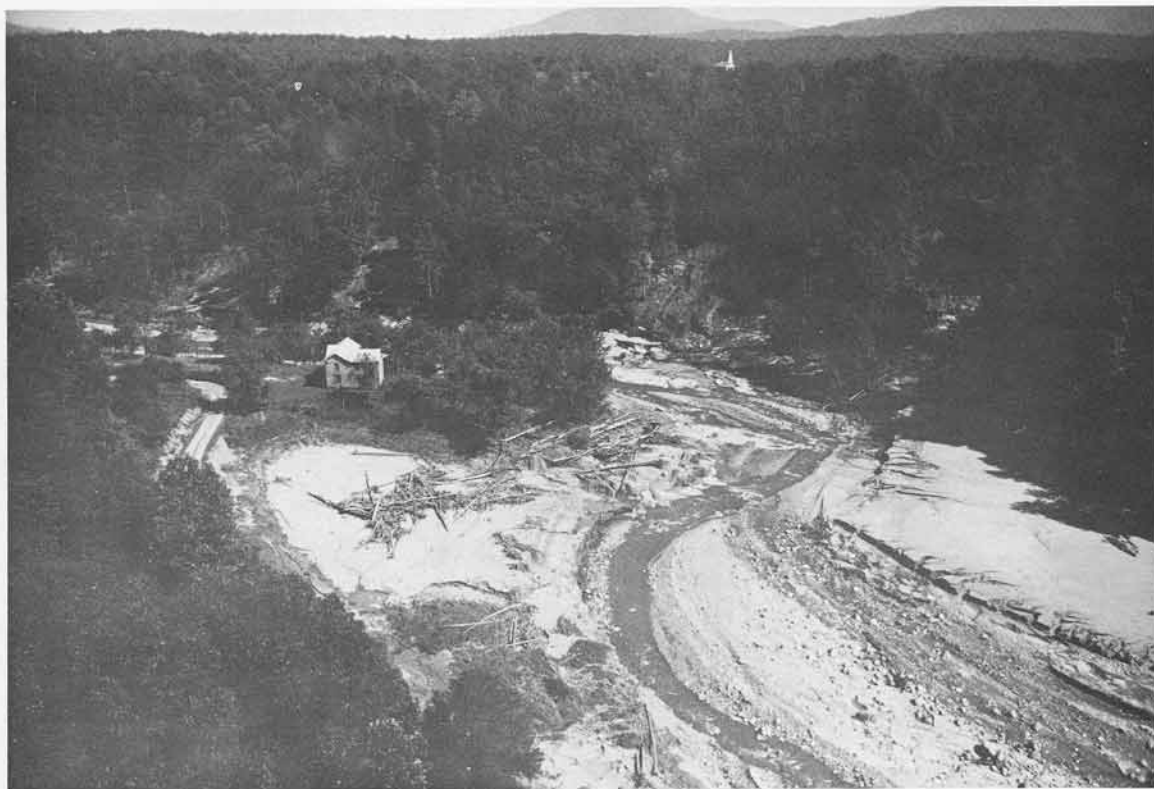
15 Stream channel incised into a newly formed flood plain; two scarps have been cut into the terrace on the right bank. Boulders and gravels that were chaotically deposited are flanked by finer grained sediments of the flood plain. Along Davis Creek looking northeastward to Mt. Zion Church, about 1.5 miles southwest of Woods Mill.

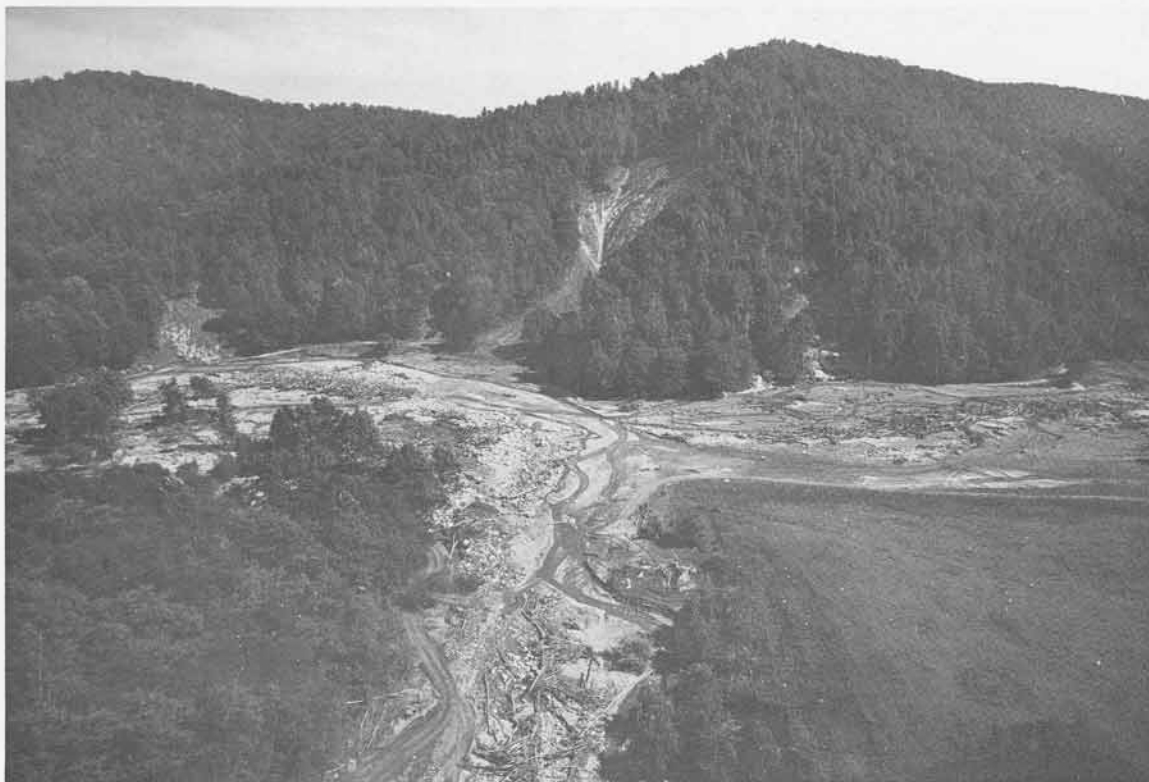
16 Confluence of tributary with Davis Creek where debris trains were deposited along watercourses. Dendritic pattern has developed in an irregular-shaped chute above channel (center background). Looking southeast along North Prong (foreground) to its junction with Davis Creek (midground), about 3.2 miles southwest of Woods Mill. The junction of State Roads 623 and 625 was obliterated.

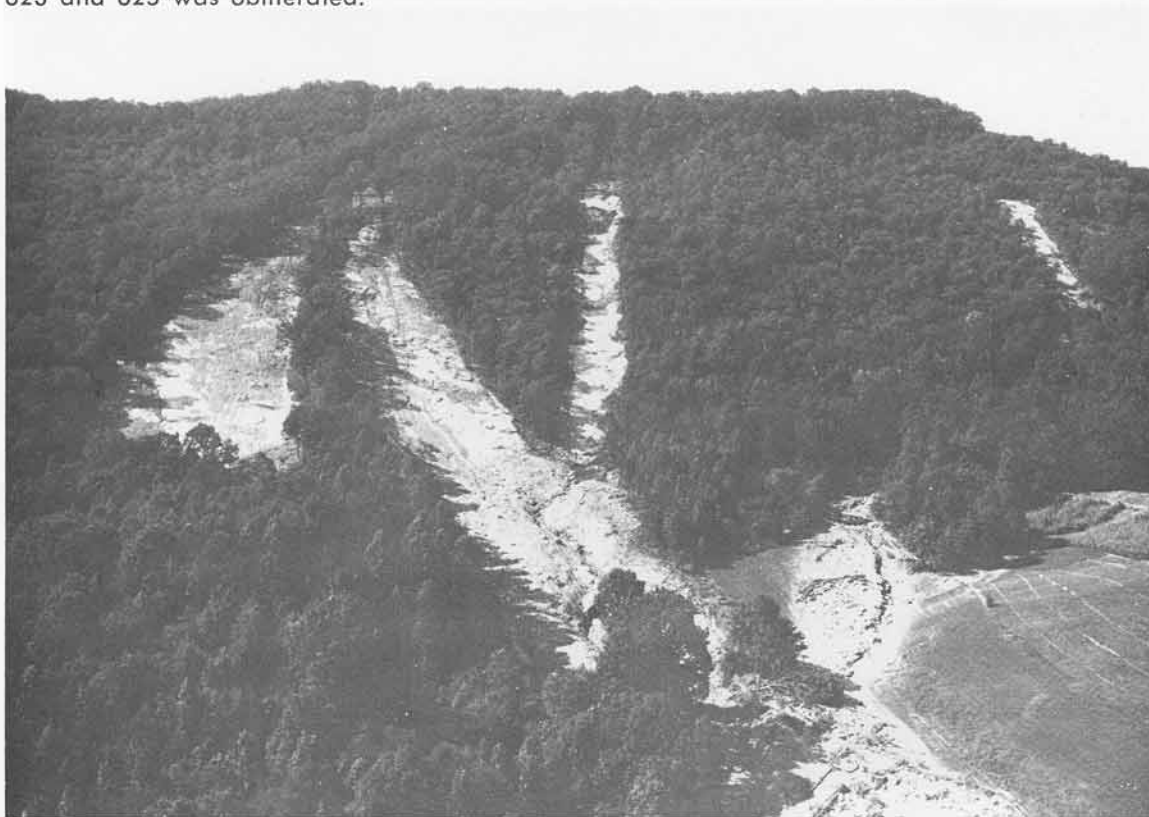
17 Coalescing chutes on ridge slope with rubble accumulation at base of scars. Along southeast face of ridge about 0.5 mile west of Myndus.

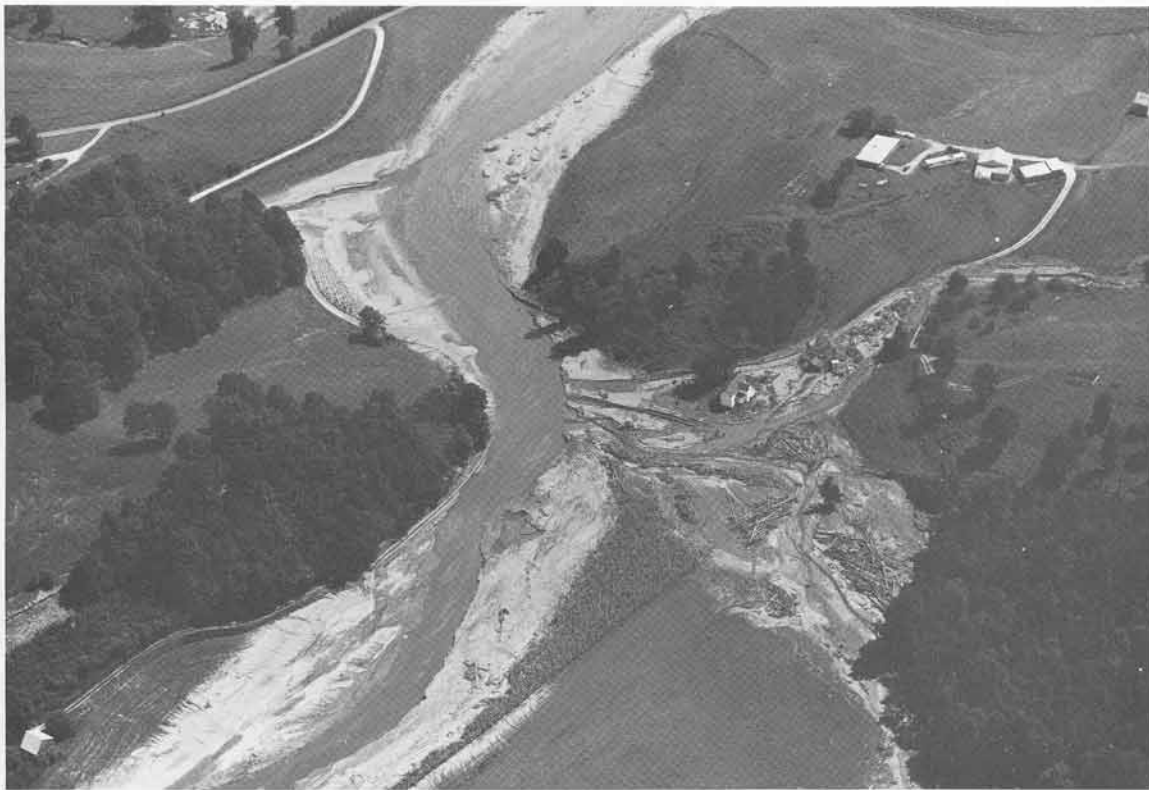
18 Constriction of debris veneer (center) and its truncation by Dillard (Hargrove) Creek in Stevens Cove. About 1.6 miles west-southwest of Lovington.

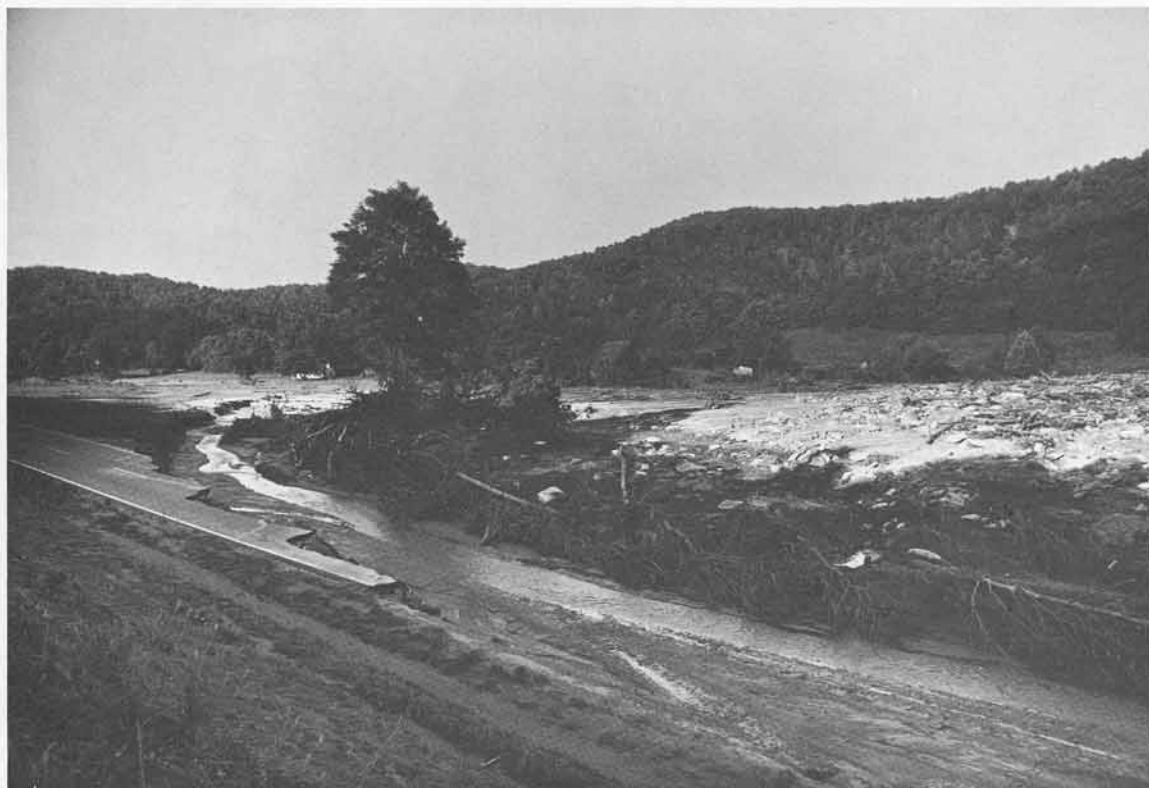
19 Toe of debris cone truncated by Muddy Creek; destruction of U. S. Highway 29. About 5.7 miles north of Lovington.

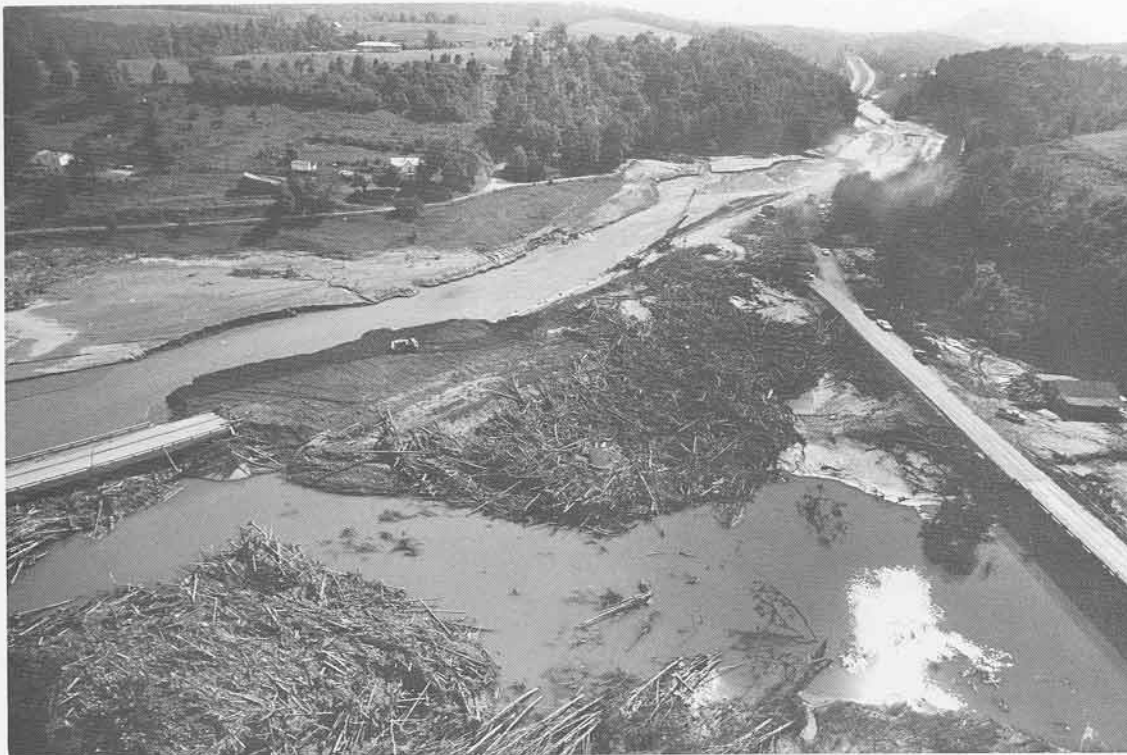
20 Large quantities of sand and silt and jumbled piles of trees deposited at the confluence of Rockfish River and Muddy Creek. The channel of Muddy Creek (background) has cut into the silt deposit. Looking southward along U. S. Highway 29 at Woods Mill; State Highway 6 at lower right.

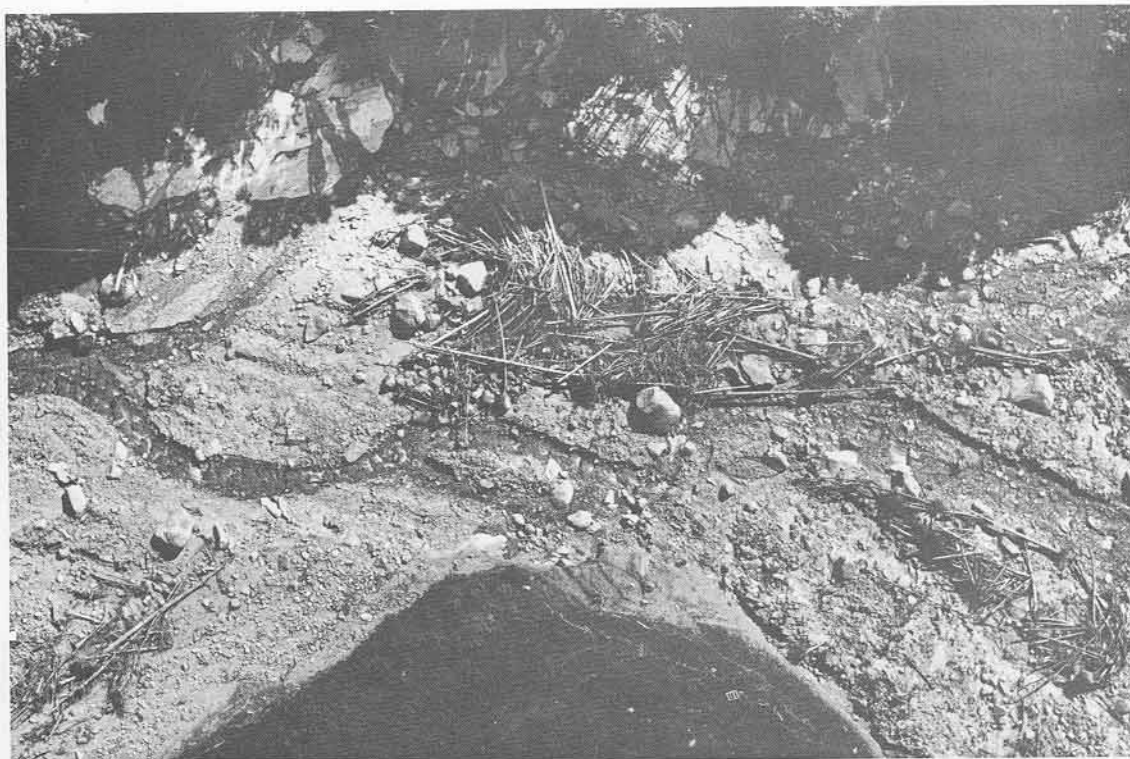
21 Chaotic deposit of boulders and tree trunks through which water of Davis Creek has begun initial entrenchment. In the headwaters of Davis Creek, about 5.5 miles southwest of Woods Mill.

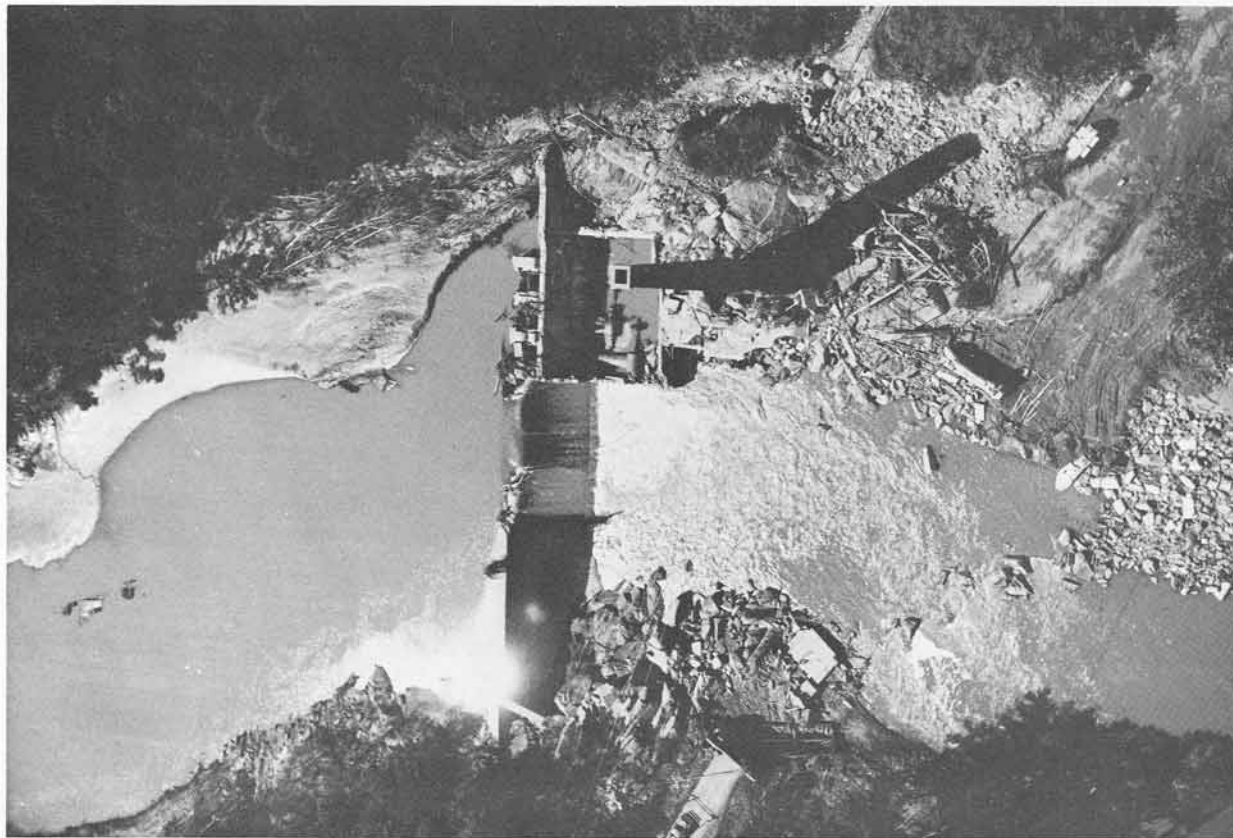
22 Devastated power plant of Alberene Stone, A Division of the Georgia Marble Co.; only generator and stack remain; bridge span of State Road 693 just south of dam was obliterated. Schuyler.

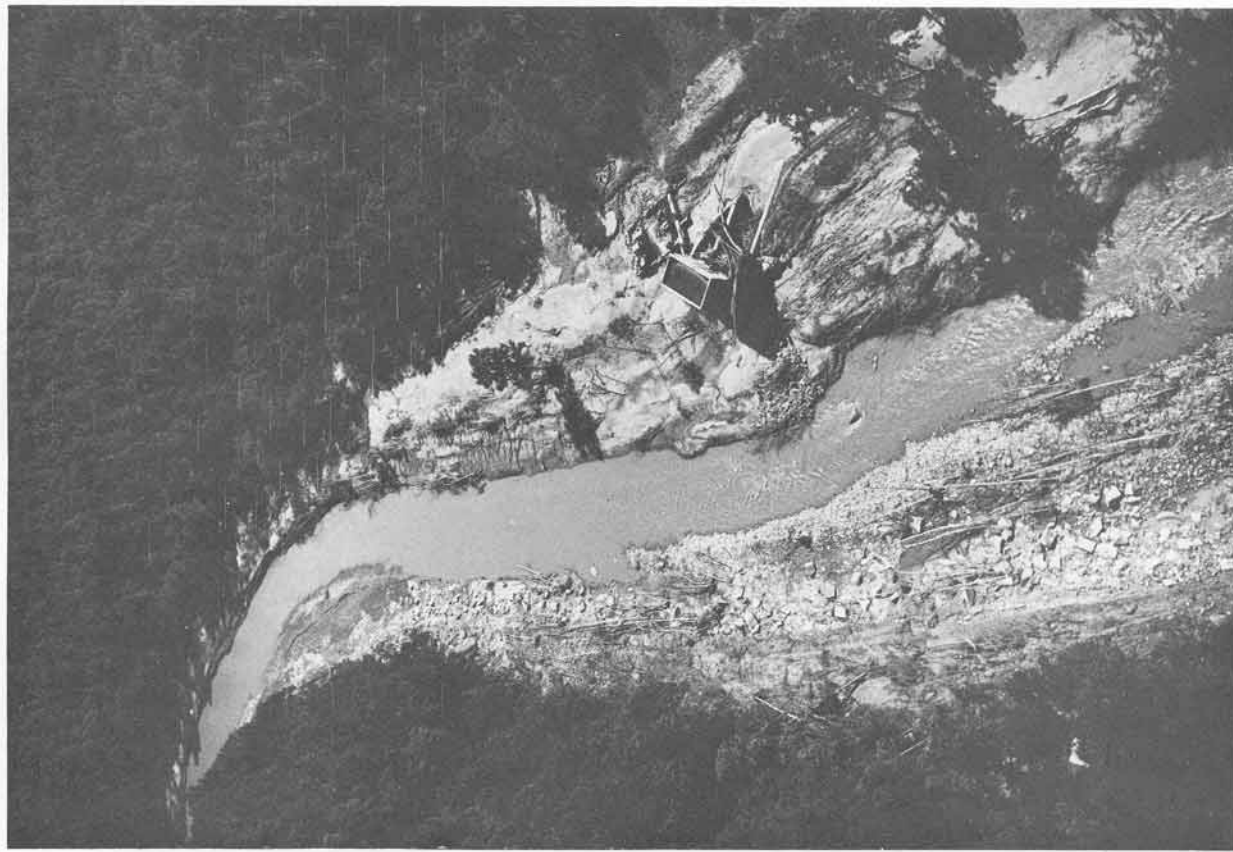
23 Remains of filtration plant on right bank of Rockfish River; tree trunks aligned with flow direction of flood water; graded rubble deposited along foot of cut-in bank. About 1 mile west of Schuyler.

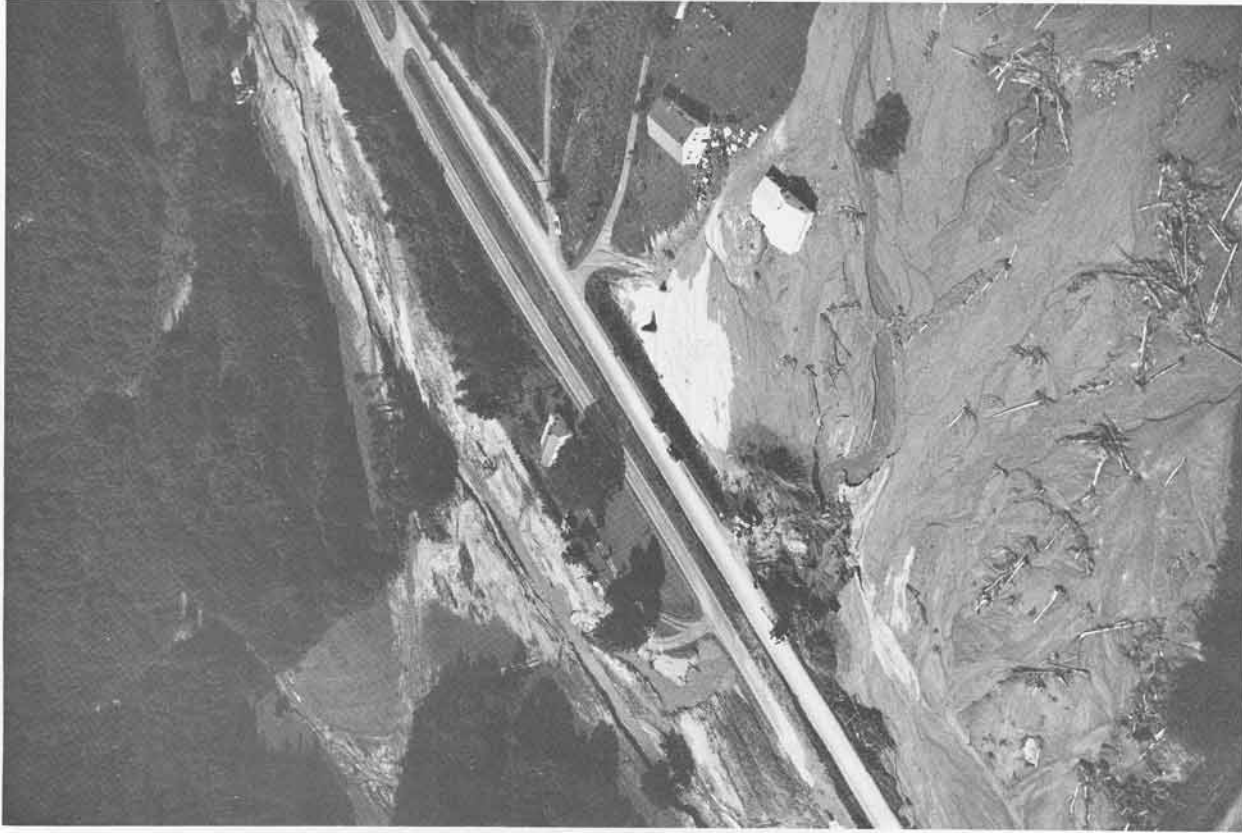
24 Mudflow impeded by fill of U. S. Highway 29; surface of flow is covered with an anastomosing pattern left by braided streams and rivulets. House (center right) is partially buried in flow. Looking northwest at confluence of tributary from Melton Hollow with Muddy Creek, about 1.5 miles north of Lovingston.

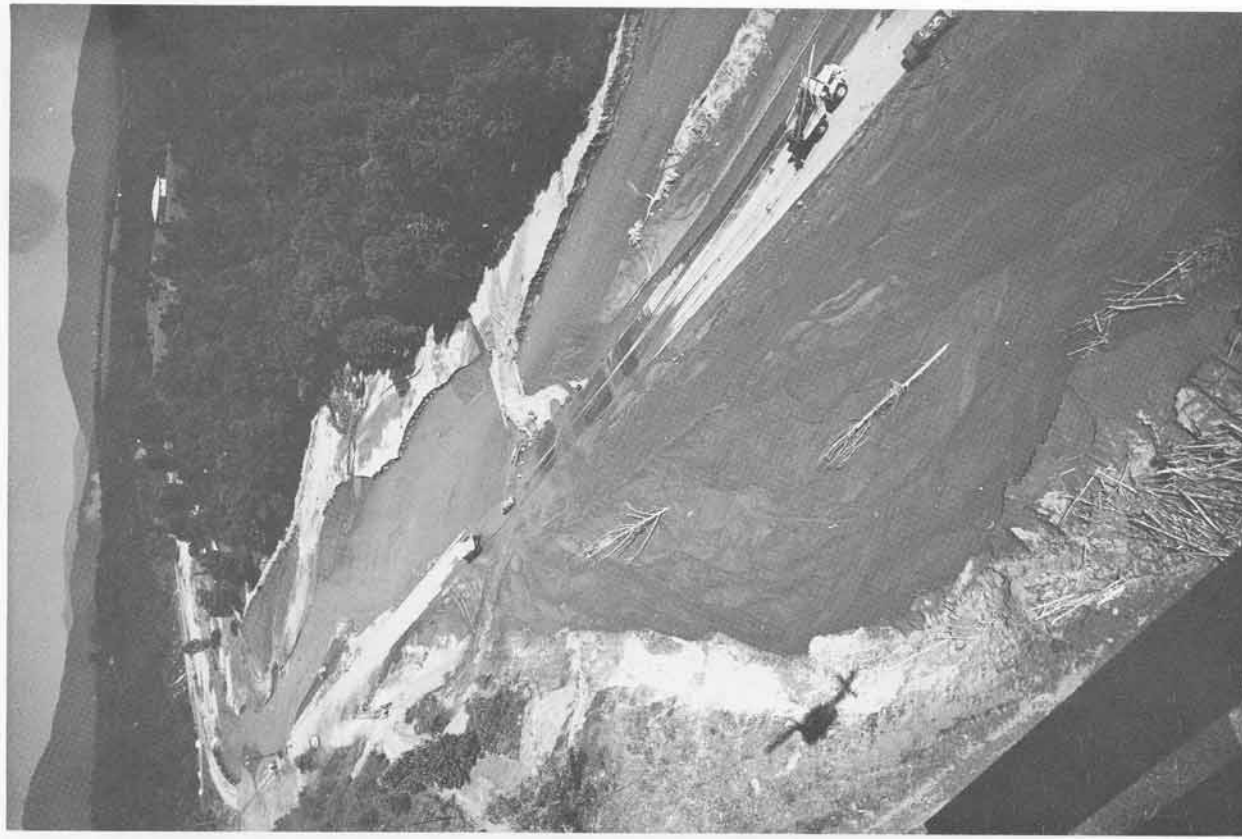
25 Siltation and channel scour adjacent to U. S. Highway 29. Just below confluence of Muddy and Davis creeks, about 0.5 mile southwest of Woods Mill.

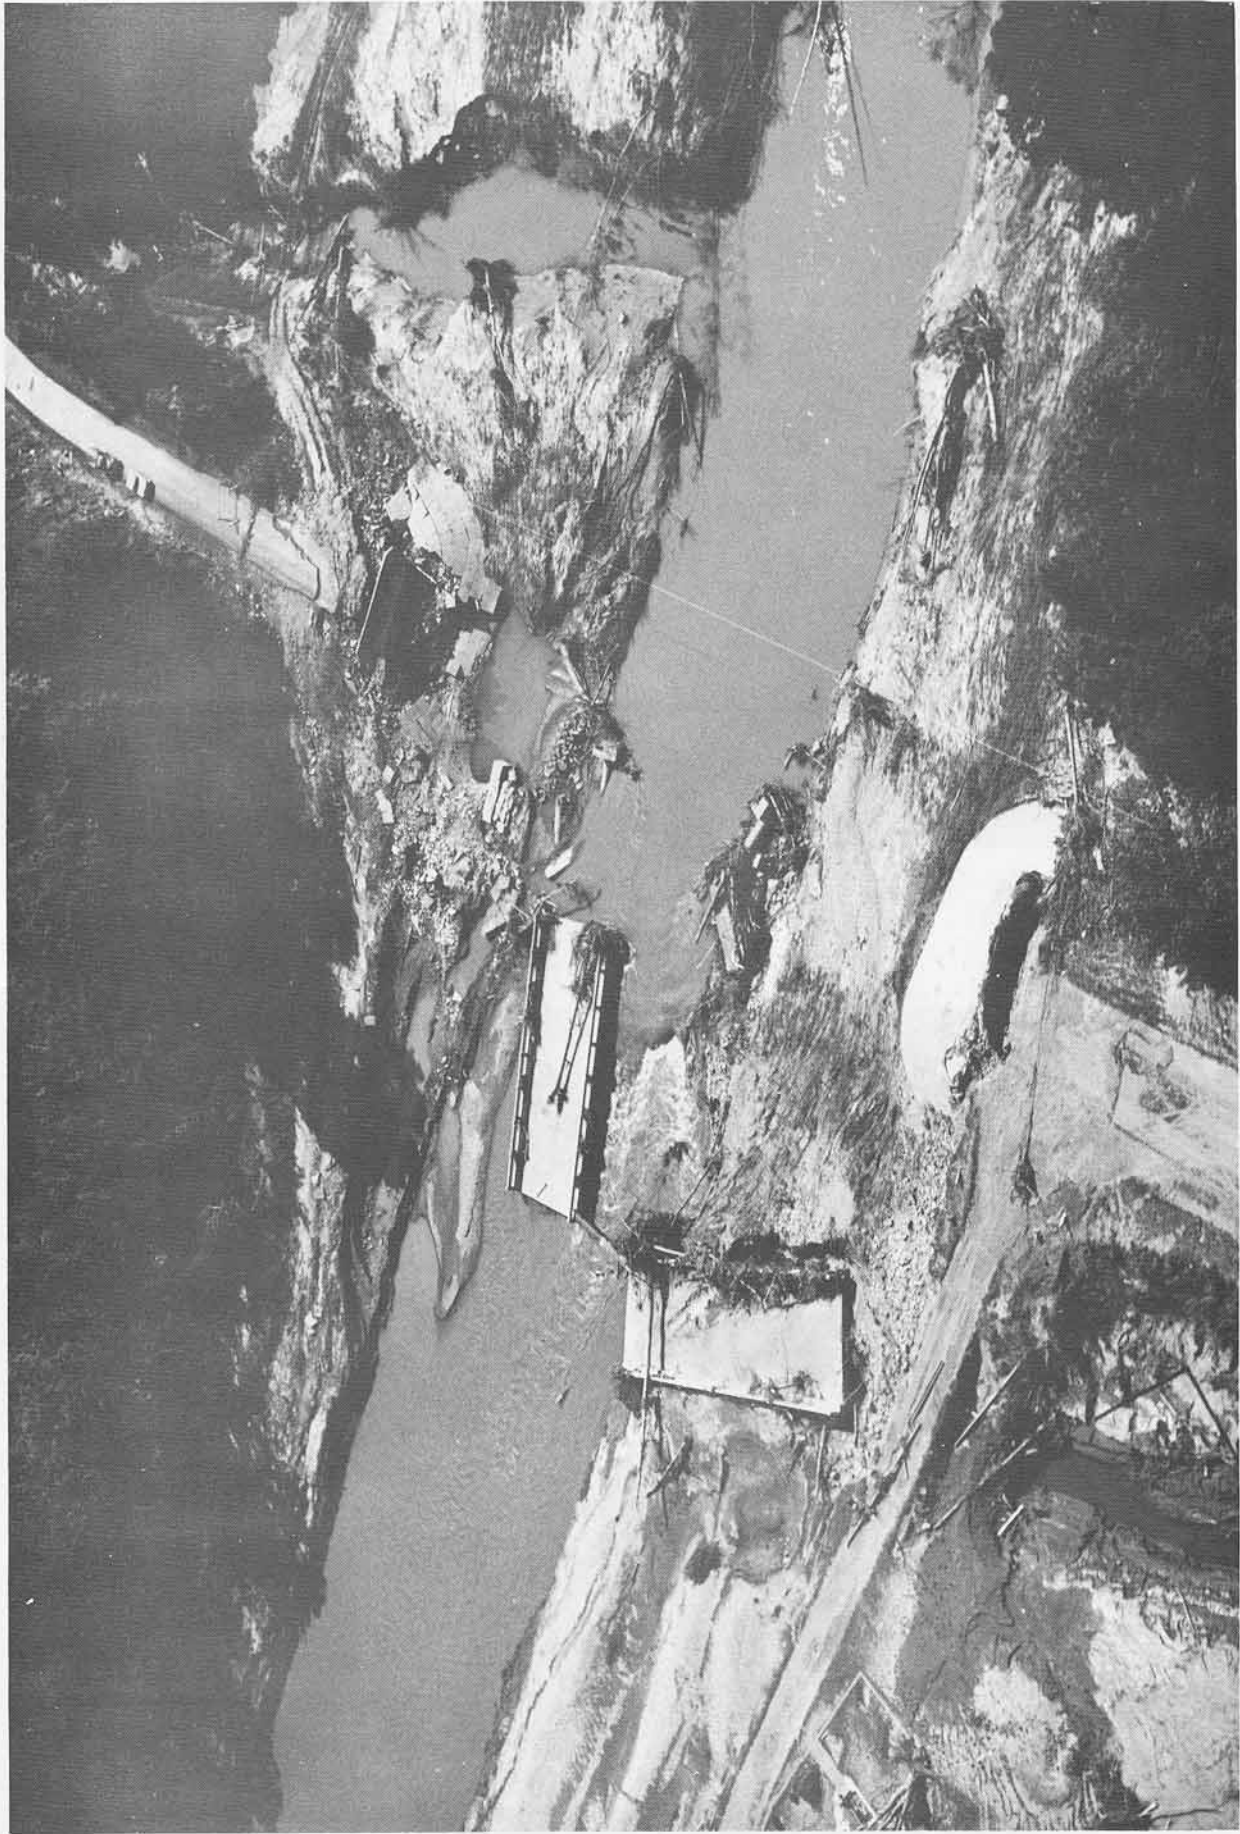
26 Bridge sections torn loose from abutments; tree trunks are aligned parallel to stream flow; channel cut into flood debris (background). About 0.4 mile southeast of Rockfish at the State Road 617—Rockfish River crossing.

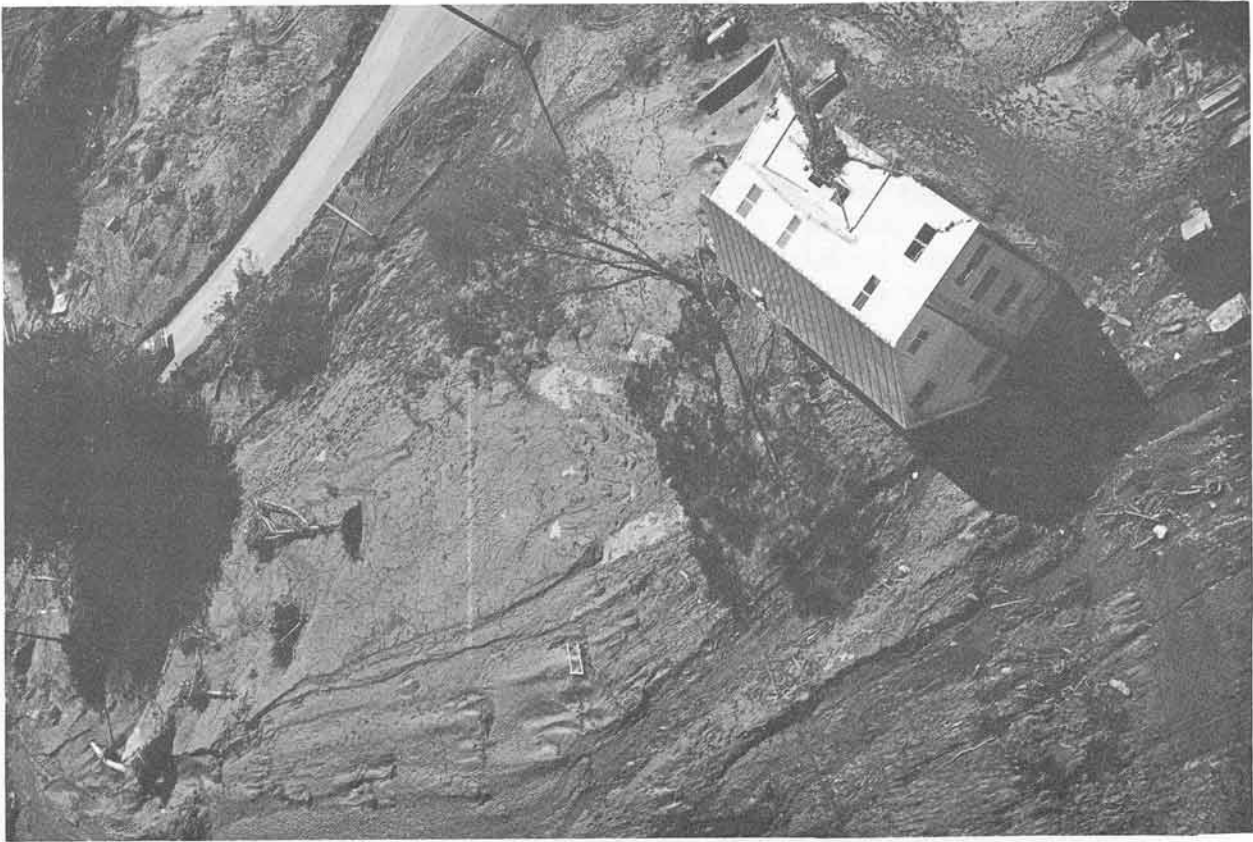
27 Residence lifted from its original position (part of foundation wall and pillar visible) and turned on its side; probable high-water mark on side (foreground). Roseland.

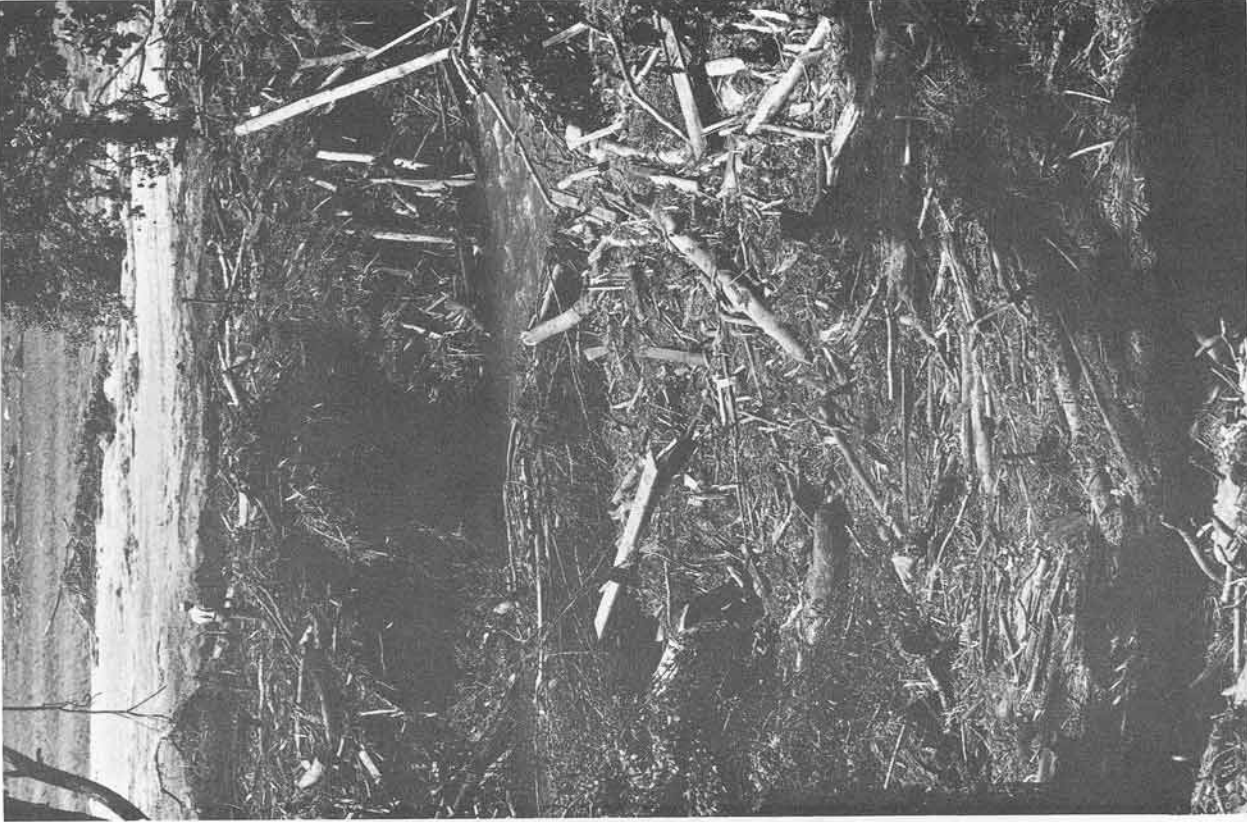
28 Jumbled mat of tree trunks and limbs deposited along tributary to Tye River. Location just south of area in illustration 27, Roseland.
